FIELD INSPECTION

Project Name:	Mountain Valley Pipeline	Inspector:	Matthew Grant
Inspection Date:	Thursday, July 25, 2019	Project Contact:	Brian Clauto
Spread: Franklin Co. MP251 St13260	Spread H	Weather (Wet/Dry/Rain):	Dry

FIELD INSPECTION PHOTO LOG

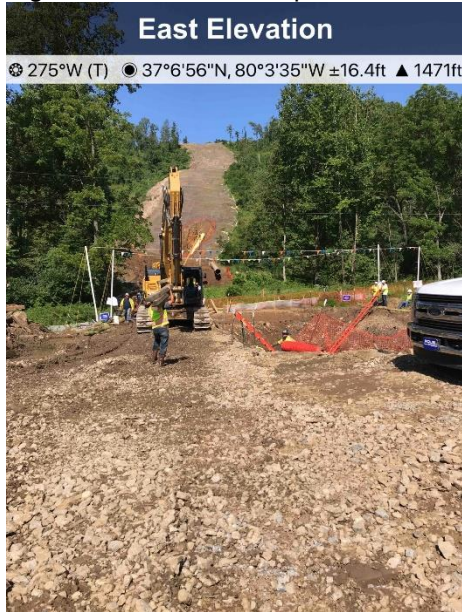
Fig. 1 Flanders Rd bore pit site.

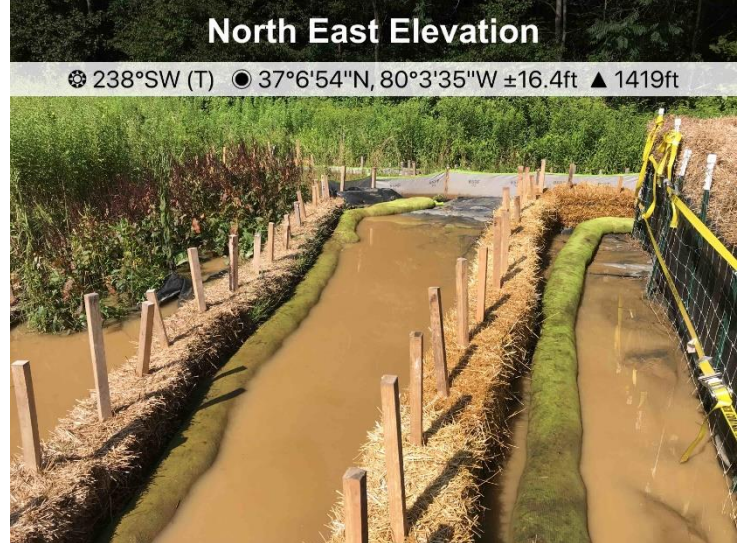
Fig. 2 Dewatering structure at the Flanders bore pit site was functioning at the time of the inspection.

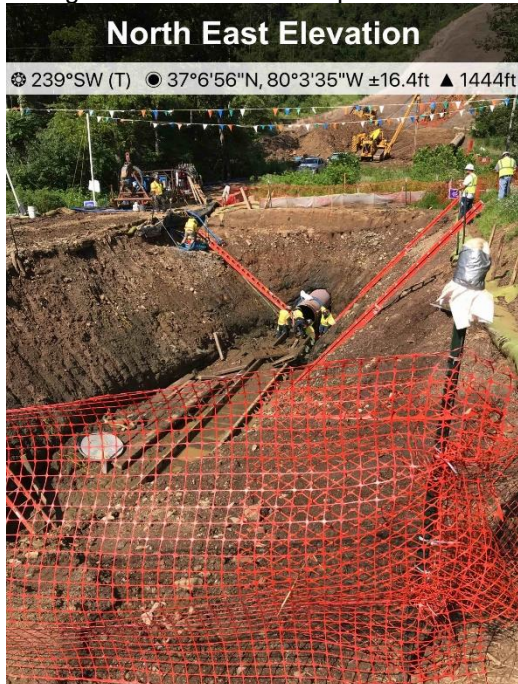
Fig. 3. Flanders Rd bore pit site.
